AIRCRAFT ACCIDENT REPORT

UNCONTAINED ENGINE FAILURE
DELTA AIR LINES FLIGHT 1288
MCDONNELL DOUGLAS MD-88, N927DA
PENSACOLA, FLORIDA
JULY 6, 1996

**Adopted: January 13, 1998
Notation 6725C**

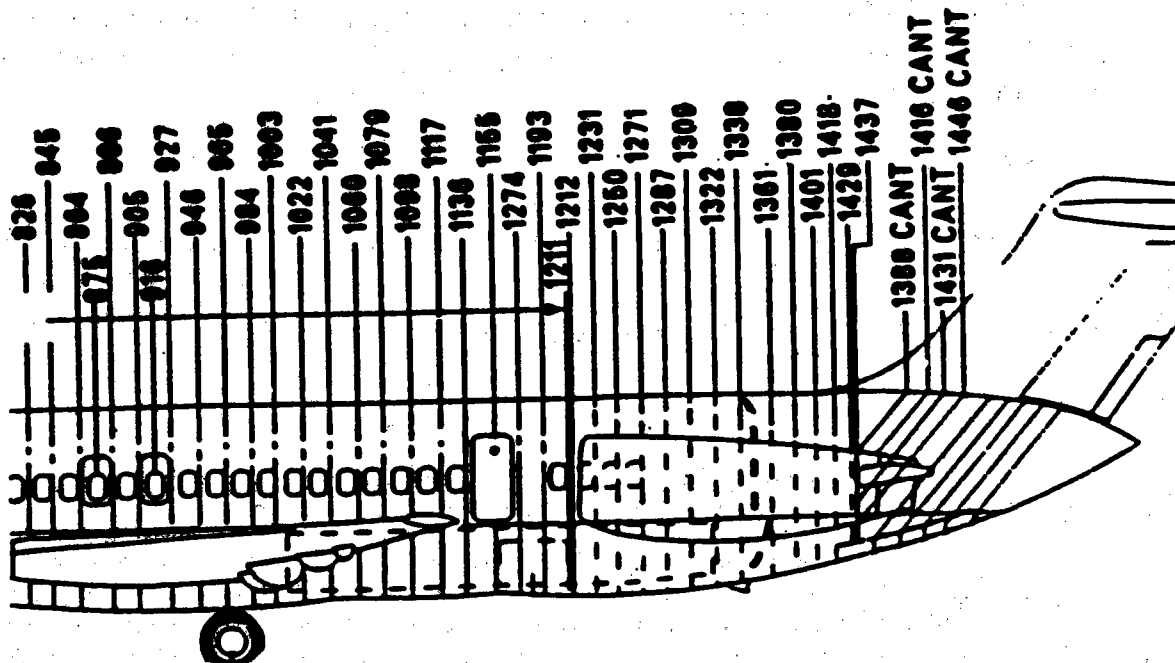
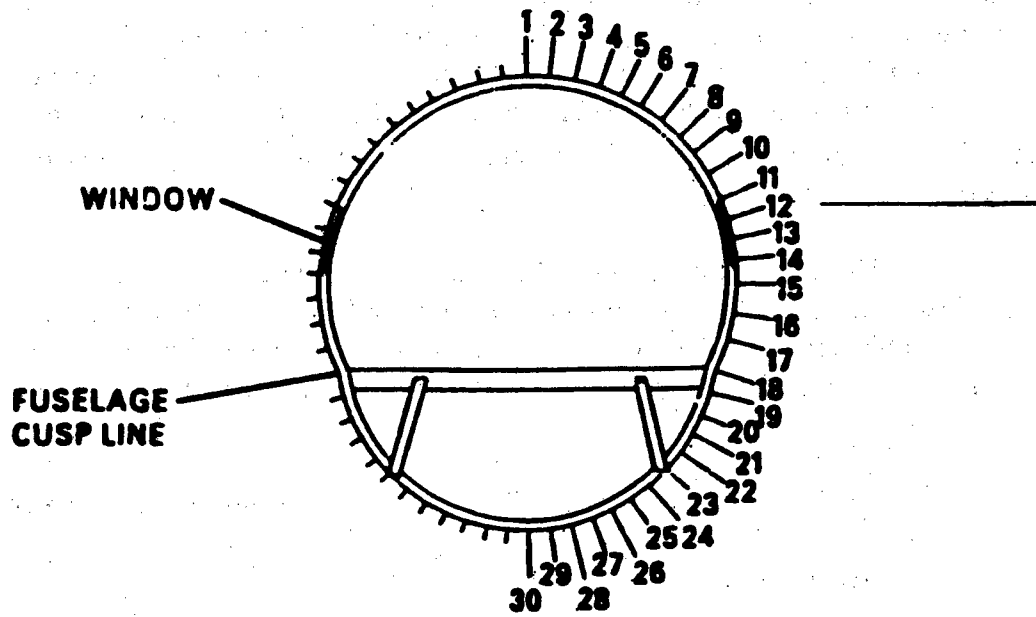
Figure 2.—Fuselage station and longeron identifications.

found between fuselage stations (FS) 1250 and FS 1282 (adjacent to row 37) and from the top of the window to longeron 2 (see figure 2).¹² Seven exit holes, punctures, and tears were documented on the right fuselage skin between FS 1228 and 1271 (just forward of row 37). Most of the wires in the wire bundle located along longeron 4 (on the right side of the fuselage) were severed near FS 1250. Of the 154 wires in the bundle, 146 had been severed. Four of the severed wires were channel differential protection wires that compared incoming and outgoing current for the right generator.¹³ No evidence of penetrations existed below the floor level on either side of the fuselage.

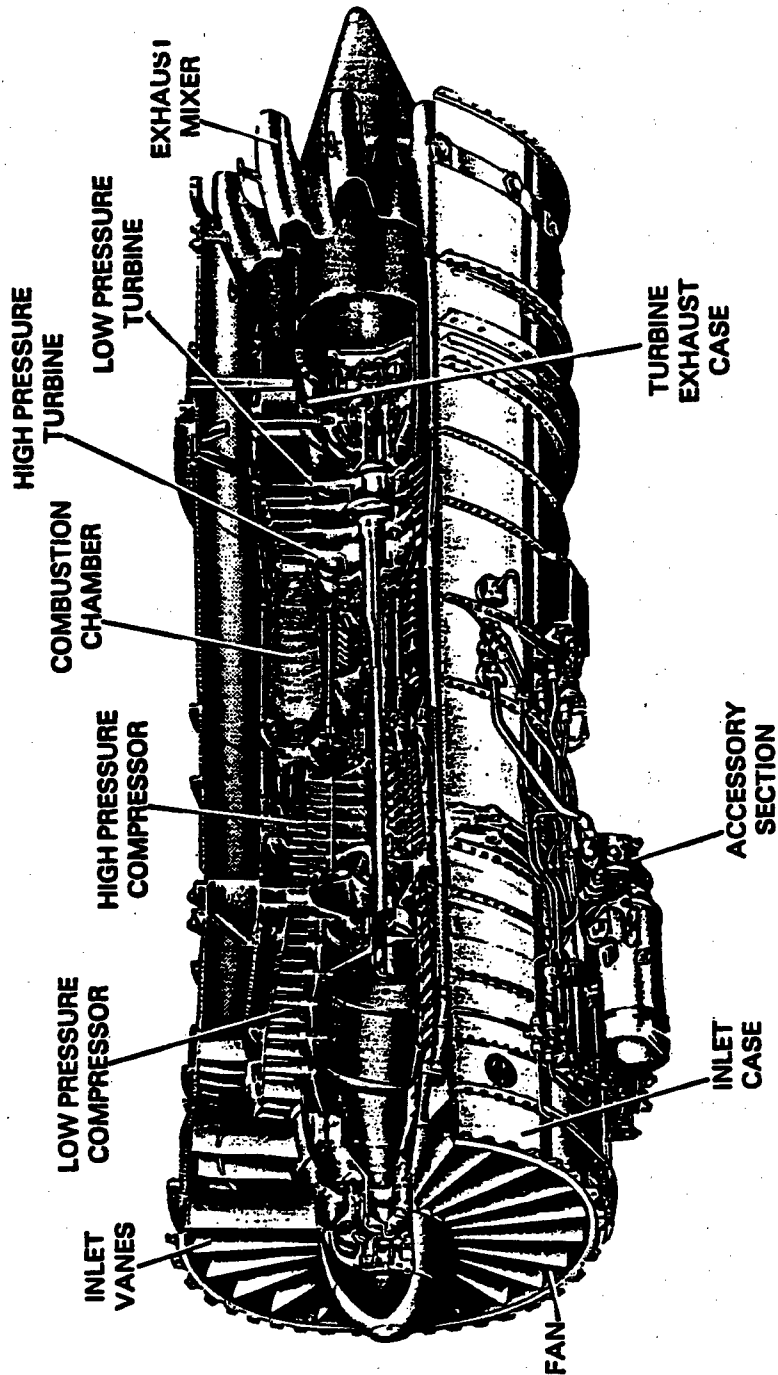
Figure 3.—Cross section of Pratt & Whitney's JT8D-200 series engine.

The airplane was equipped with two Pratt & Whitney JT8D-219 turbofan engines. The JT8D-200 series engine is an axial-flow front turbofan¹⁵ with a 14-stage split compressor,¹⁶ a 9-can combustion chamber,¹⁷ and a split, 4-stage reaction impulse turbine (see figure 3).¹⁸ The No. 1 (left) engine, SN 726984, had a total operating time of 7,371.7 hours and 5,905 operating cycles¹⁹ since new. Delta was the original operator of the engine. The engine had been installed on the accident airplane on January 1, 1996, and had since then accumulated 1,528 hours and 1,142 cycles. It had been removed from another Delta airplane on December 21, 1995, following a report of "smoke in cabin." The problem was identified as an oil leak in the compressor section, and a carbon seal was replaced.

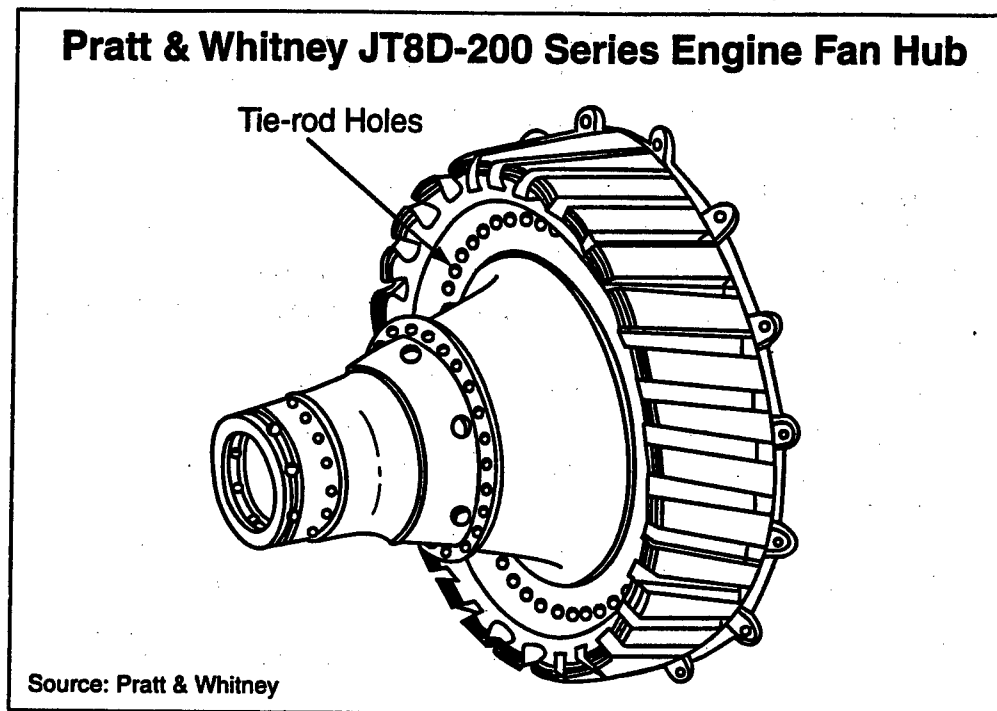
Figure 4.—Pratt & Whitney JT8D-200 series engine fan hub.

dovetail slots. The 2.91-inch deep tierod holes were located around the circumference of the hub bore and alternated with 24 smaller diameter stress redistribution (SR) holes (see figure 4).²¹ The fan hub was forged from a titanium-based alloy containing 6 percent aluminum and 4 percent vanadium.
